# **Results From a ¼ Million km, Heavy-Duty Truck Trail, Using FBC Regenerated DPFs**

**P. Richards**  
Associated Octel Company

**W. Kalischewski**  
Octel Deutschland GmbH

2004 SAE World Congress  
Detroit, Michigan  
March 8-11, 2004

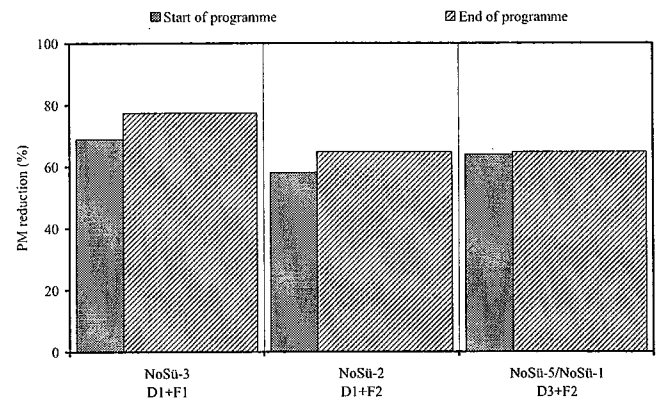
The reference truck (NoSü-6) produced a 26% increase in the PM emissions whilst the trucks with the DPFs fitted showed a difference in PM emissions over the programme ranging from a decrease of 8% on truck NoSü-3 to a 23% increase on truck NoSü-1. Using the reference truck as the baseline, the PM reduction as a result of having the DPF fitted was therefore greater, on each of the three trucks considered, at the end of the programme when compare to the start of the programme. This is shown graphically in Figure 2.

Figure 2 Cold start test PM reduction with DPF

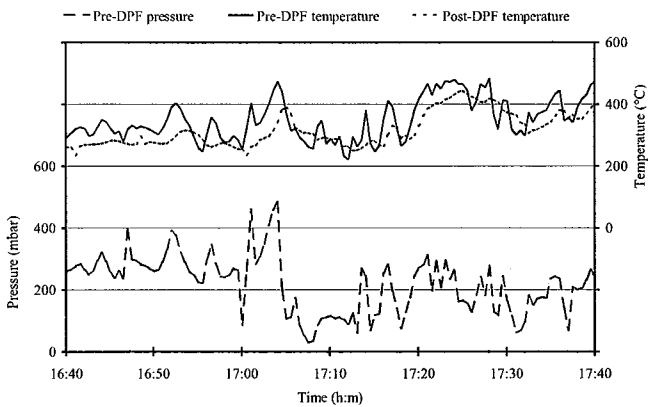
Despite the absence of frequent large exotherms it was still possible by careful processing of the data, to identify regeneration events. The temperature and pressure data for one such event is demonstrated in Figure 5. This data is from truck NoSü-4 on the 26<sup>th</sup> June 2001.

Figure 5 Regeneration event on truck NoSü-4

From the data presented in Figure 5 it is clear that there was no large exothermic event during this time period, however there is a noticeable shift in the pre-DPF pressure characteristics at about 17:05. This also corresponds to a period when the pre-DPF temperature exceeded 400°C for a period of about between 2 and 3 minutes with a peak temperature of 473°C. Although this event is followed by a further period where the temperature exceeds 400°C, after only a short period of time, it was 142 operating minutes since the last occurrence of a pre-DPF temperature of greater than 400°C for more than a minute.

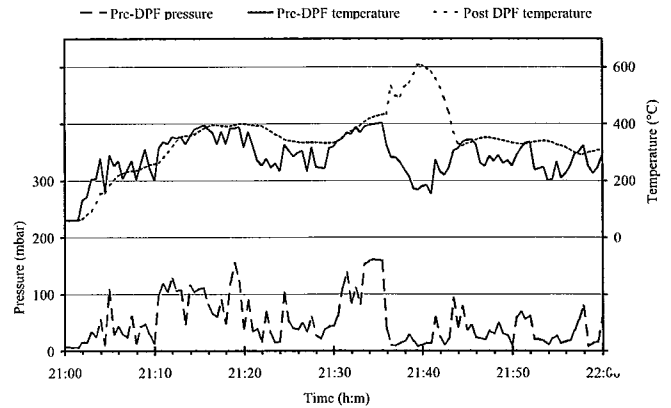
Occasionally atypical operating patterns would occur resulting in larger accumulations of soot and correspondingly larger exotherms. One example is shown in Figure 6. This figure shows data from truck NoSü-3 on 9<sup>th</sup> September 2001.

Again there is a shift in the exhaust back pressure characteristic, although in this case it is less well defined. This corresponds to the pre-DPF temperature reaching a peak of 403°C, although it was noted in the previous section that the pre-DPF temperature on this truck appeared lower than on the other truck and this was

probably due to the positioning of the thermocouple. Allowing for this the peak temperature was about 430°C to 440°C and it was about 8 operating hours since similar pre-DPF temperatures were achieved. The quantity of soot accumulated in the DPF prior to this regeneration event would therefore be greater than for other events.

Figure 6 Regeneration event on truck NoSü-3

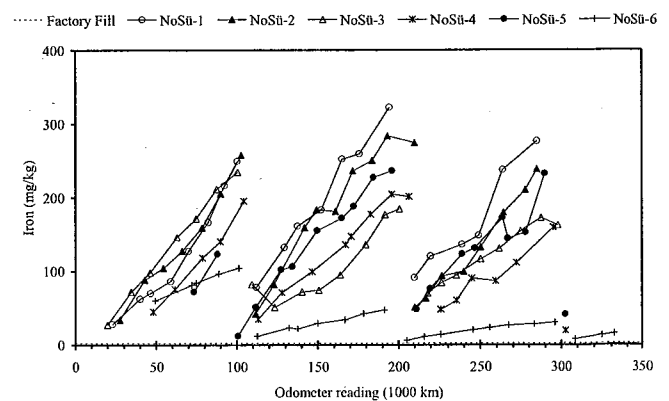
Iron was being added to the fuel at the rate of 16 mg/kg or 20 mg/kg, depending on which FBC was used in that particular truck. Some of this treated fuel may enter the lubricating oil via the cylinder walls. Some of the combustion products will also enter the lubricating oil via the blow-by gases. It would therefore be expected that there would be a greater increase in the amount of iron in the lubricating oil, than if an iron based FBC was not used. The levels of iron detected in the first sample of oil from the trucks fitted with DPFs and using the FBC were lower than the trend for the reference truck. This "offset" could be due to differences in initial wear rates produced during the running-in period. The rate of increase in iron content was higher for all the trucks fitted with DPFs. The history of the iron concentration in the oil samples is shown in Figure 8.

Figure 8 Iron concentration in the lubricating oil

During the first oil fill the rate of increase in iron concentration for all the trucks fitted with DPFs was very similar. During the second and third oil fills the rate of increase of iron concentration was greater for the three trucks that were run on fuel treated with FBC labelled F2. This is to be expected as F2 contains 20 % more iron than does F1. For the trucks using the FBC, the

additional iron in the oil is only equivalent to between 1% and 1.5% of the iron added to the fuel. The concentration of iron in the lubricant from the trucks fitted with DPFs is approximately an order of magnitude greater than that for the reference truck without the DPF. Therefore changes in the iron concentration due to increased wear would be hard to detect within this increased iron concentration. Thus the concentration of iron cannot realistically be used as an indication of wear rates in the trucks with the DPFs fitted.

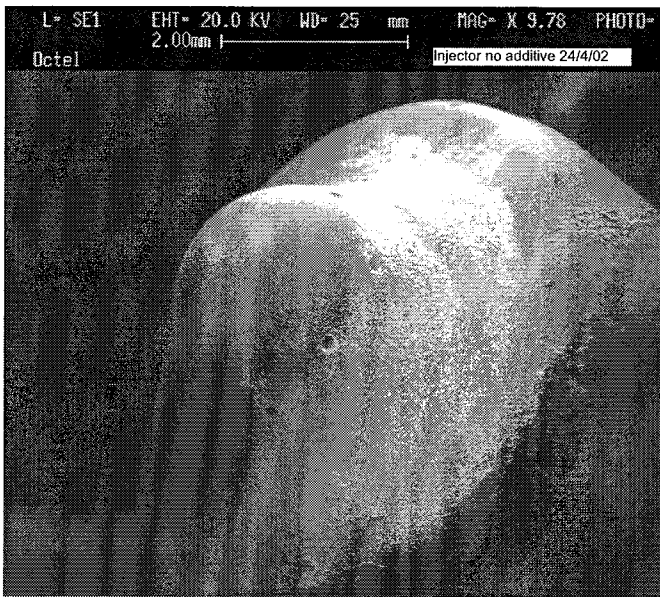
Significant levels of deposit were apparent around all eight of the holes with no bare metal visible. This was confirmed by the general view of the nozzle tip, which is shown in Figure 10. There was a uniform light deposit over the entire nozzle tip. Some of this deposit layer was removed and subject to X-ray analysis. Besides the Ca and S that were detected in the deposits within the holes there was also Zn and P present which were also present in the lubricating oil. The presence of Sr and K,

Figure 10 General view of injector from reference truck

as with the Ti within the holes, cannot readily be explained. Small amounts of Sr can be associated with the Ca within the lubricating oil, but at a much lower level than was detected here.

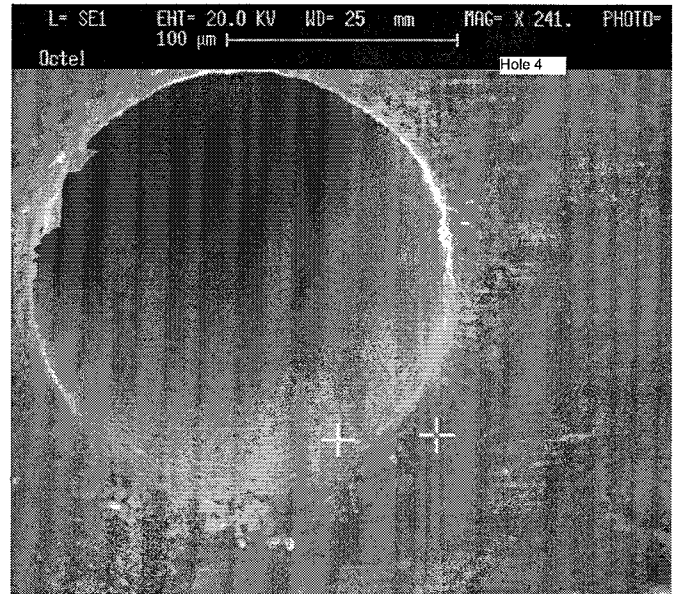
The 8 holes of the injector nozzle were viewed individually on the SEM. All the holes were relatively free of deposit accumulation with only a small ridge of deposit around the edge of the hole. The machining marks on the tip of the nozzle were generally visible around the holes. These can be seen as horizontal lines in the example shown as Figure 12..

Figure 12 Hole of injector using F1.

Spot X-ray analysis of the deposit in and around the holes was carried out, these spectra were generally very similar. The deposit inside the holes contained high levels of Sr, with a peak height similar to that of Fe. Very small quantities of Ca and S were also detected. The high relative levels of Sr suggest that this deposit is formed from the decomposition or evaporation of the fuel leaving residue of the FBC on the injector hole surface. Due to the underlying metal of the injector it was not possible to quantify the relative quantities of Fe and Sr within the deposit. The deposit on the edge of the hole showed much lower relative levels of Sr.
